Monitoring Data Record

Project Title: R-2248D – Charlotte Outer Loop COE Action ID: 200131321
 Stream Name: Trib. to Dixon Branch (Site 16) DWQ Number: 011231
 City, County and other Location Information: Mecklenburg County, Charlotte Outer Loop, R-2248D Right of Project Station 13+50 Ramp 2D
 Date Construction Completed: February 2005 Monitoring Year: (4) of 5
 Ecoregion: 8 digit HUC unit 03050103
 USGS Quad Name and Coordinates: _____
Rosgen Classification: Proposed C4 stream type classification
 Length of Project: 548 ft. Urban or Rural: Urban Watershed Size: _____
 Monitoring DATA collected by: M. Green and J. Young Date: 1/25/12
 Applicant Information:
 Name: NCDOT – Roadside Environmental Unit
 Address: 1425 Rock Quarry Rd, Raleigh, NC 27610
 Telephone Number: (919) 861-3772 Email address: mlgreen@ncdot.gov
 Consultant Information:
 Name: _____
 Address: _____
 Telephone Number: _____ Email address: _____
Project Status: _____

UT to Dixon Branch

Site 16

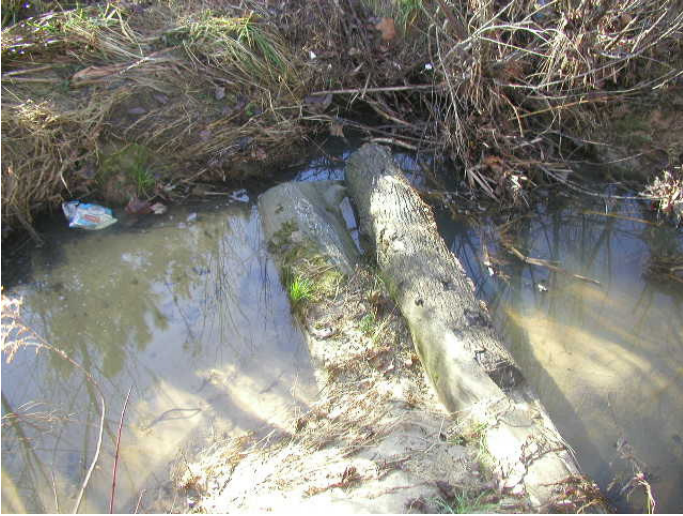
Log Sill #1 (side view)

This completes the Year 4 Winter evaluation for the UT to Dixon Branch (Site 16) stream relocation. NCDOT installed log sills in May 2010 to stop the previously noted headcut and further stabilize the stream. Three of the four installed log sills have water piping around these structures at the time of the monitoring evaluation but massive amounts of sediment deposited from upstream onto the site have improved these log sills. The sediment has filled in some of the voids in and around these log sills. A bankfull event has occurred at the site since the last evaluation. NCDOT will continue to monitor for channel stability at this stream relocation.

Date 1/25/12	Between PP#1 and PP#2	Between PP#1 and PP#2	Between PP#1 and PP#2	Between PP#1 and PP#2	Between culvert outlet to PP#1
Structure Type	Log Sill #1	Log Sill #2	Log Sill #3	Log Sill #4	
Is water piping through or around structure?	Water is piping around left side of log sill	Water is flowing over log sill but is also piping around right side	Water is piping around left side of log sill	Water is flowing over log sill	
Head cut or down cut present?					
Bank or scour erosion present?		Right bank has eroded			Bank erosion present
Other problems noted?
